REPORT

OPERATIONAL SAFETY REVIEW TEAM

BUGEY

NUCLEAR POWER PLANT

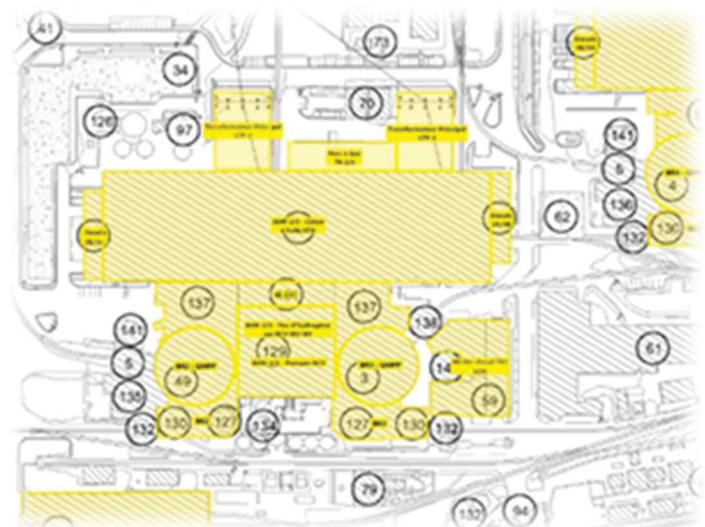
SECUREVI supports emergency teams to respond to a crisis in real time. It can also be used for training purposes, and to collect operating experience after an event (the software records details of an emergency event on a minute-by-minute basis).

Initially developed for the public emergency services, SECUREVI has been designed to meet the operational needs of the plant. Bugey is EDF's pilot site for the implementation of the software.

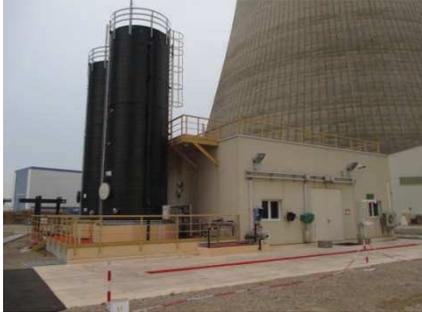
ATO injection pumps

At the plant, an injection facility injects on an ongoing basis an organic scale removal product (ATO) into the circulating water system. The idea is to prevent scale and sludge deposits in the condenser and circulating water systems. The product used is organic, harmless for the environment and contains neither phosphate nor nitrogen.

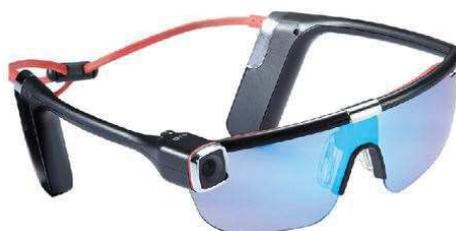
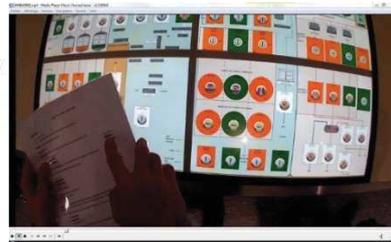
Camera goggles:

The plant training department has developed video goggles for use during training of HU champions. The videos are used to replicate the activity as experienced by the trainee, showing what he/she has actually seen, said and heard. The goggles can be operated by the instructor using wi-fi. The videos are subsequently viewed during post training critique.
